## NASA/TM—2003-212628

# Measurements of Erosion Wear Volume Loss on Bare and Coated Polymer Matrix Composites

Prepared for the 28th Annual International Conference and Exposition on Advanced Ceramics and Composites sponsored by the American Ceramics Society Cocoa Beach, Florida, January 25–30, 2004

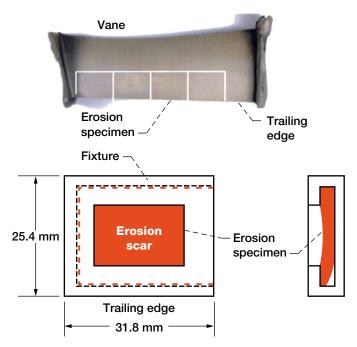
Figure 2.—Erosion specimen, fixture, and inserted erosion specimen.

Specimens (12.5 by 18.5 mm) were cut from the coated AE 3007 fan bypass vanes at a set trailing edge location and placed in the test fixture (fig. 2). The fixture was designed to accommodate specimen curvature and to retain uneroded edge area for a nondestructive evaluation baseline after the erosion test.

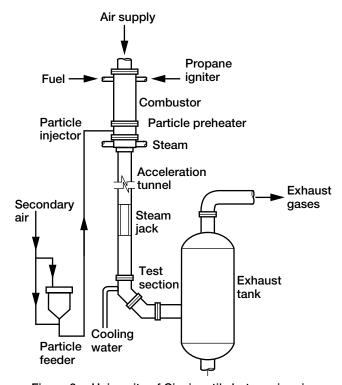
Figure 3.—University of Cincinnati's hot erosion rig.

Erosion testing was performed at the University of Cincinnati erosion rig facility (fig. 3). In addition to providing high temperatures, this facility realistically simulates all the erosion parameters that are deemed to be important from an aerodynamic point of view (refs. 8 and 9). These parameters include particle velocity, impingement angle, erodent particle size and type, and specimen size. Varying the airflow in the erosion rig wind tunnel controlled the particle velocities. Rotating the specimen fixture relative to the flow stream direction set the particle impingement angles. Impingement angles in erosion

are defined relative to the plane of the specimen fixture. Heating the flow with a combustible hydrocarbon gas or steam jacket controlled the coated PMC specimen temperature. The erosion test procedure, which used ARD impinging at angles of  $20^{\circ}$  and  $90^{\circ}$  with 15 and 10 g of ARD, respectively, was used on both uncoated and coated vane specimens at a velocity of 229 m/s at 366 K ( $200^{\circ}$ F). This procedure is also described in reference 7.

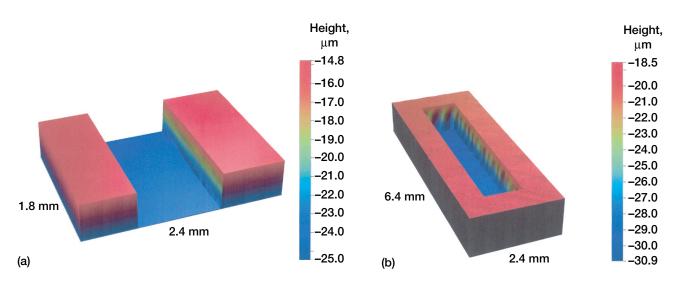
Figure 4.—Three-dimensional contour maps of a step-height measurement standard. (a) Part of the rectangular groove and its surroundings. (b) Whole rectangular groove and its surroundings.

Step-height measurement standard.—First, the measurement effectiveness of the noncontact optical profilometry was verified with a step-height measurement standard that has a rectangular groove (10  $\mu$ m deep by 1000  $\mu$ m wide by 5000  $\mu$ m long). Figures 4(a) and (b) show typical three-dimensional contour maps of part of the groove and the whole rectangular groove and its surroundings, respectively. Figure 4(a) is the contour map obtained from a single measurement, whereas figure 4(b) is the contour map that was obtained using the stitching method.

For the stitching method, continuous measurements were made over the rectangular groove and its surroundings. Then, these measurement data were stitched together to give the contour map shown in figure 4(b). After stitching, volume analyses were conducted with the stitched contour maps. The mean value and standard deviation of the volume of the rectangular groove were obtained from four stitched contour maps, which were from measurements taken on different days. The volume of the rectangular groove was computed directly.

*Volume of measurement standard.*—Figures 11(a) and (b) present the measured volume values of part of the groove and the whole rectangular groove in the step-height measurement standard, respectively. Their three-dimensional images are shown earlier in figures 4(a) and (b).

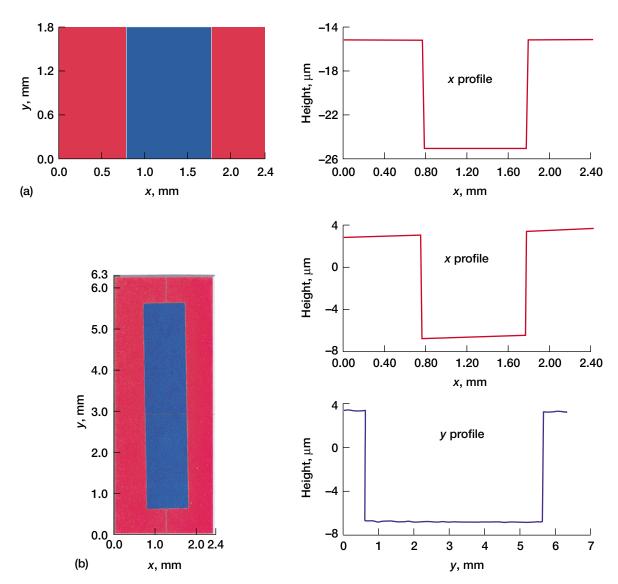
Figure 5.—Depth profile of a step-height measurement standard. (a) Part of the rectangular groove and its surroundings. (b) Whole rectangular groove and its surroundings.

For the depth-measuring method, two-dimensional cross-sectional profiles of the step-height standard (rectangular groove) were taken. Examples of the two-dimensional, cross-sectional profiles of the rectangular groove are shown in figures 5(a) and (b). The depths of the rectangular groove were obtained at eight locations. Then, the volume of the rectangular groove was calculated simply by using the mean value of each of the measured depths, long sides, and short sides of the rectangular groove.

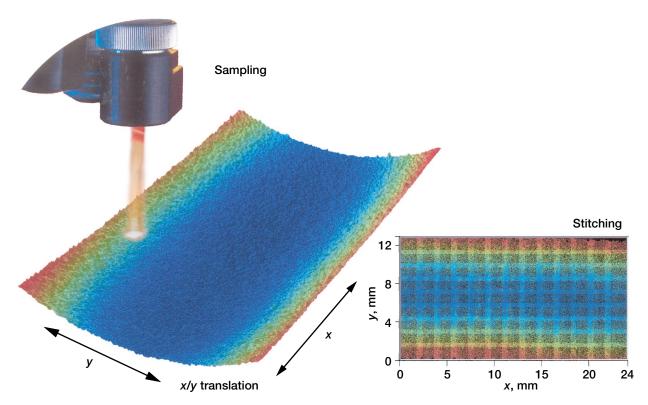
Figure 6.—View of sampling and stitching.

For the stitching method, the concave surface of the as-received, uneroded specimen was sampled and measured. Continuous measurements were conducted over a given area. These measurements were stitched together to give a larger sampling area of a specimen (e.g., the 12 by 24 mm area in fig. 6).

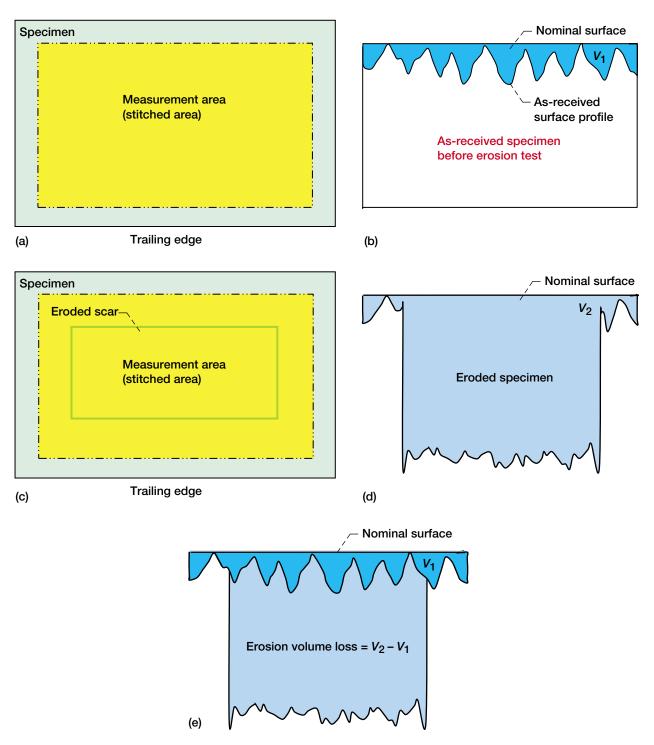
Figure 7.—Stitching method. (a) Measurement of uneroded specimen. (b) Natural volume,  $V_1$ , of uneroded surface. (c) Measurement of eroded specimen. (d) Natural volume,  $V_2$ , of eroded specimen. (e) Erosion volume loss.

Before erosion, a given area (e.g., 12.5 by 18 mm) of the uneroded vane coupon specimen was analyzed with the noncontact optical profiler (fig. 7(a)). The measurement data were stitched together to give a plot of the stitched area with surface statistics. The natural volume of the stitched area, in which the as-received surface before erosion would hold if it were covered just to the nominal surface of highest peak, was obtained (fig. 7(b)). In other words, the volume necessary to submerge the stitched area of the vane coupon specimen surface was calculated. This calculated volume is designated  $V_1$  in this investigation.

After erosion, the given area (12.5 by 18 mm) of the eroded specimen was again analyzed with the noncontact optical profiler (fig. 7(c)). The analyzed area was always larger than that of the erosion wear scar. The measurement data were stitched together to give a plot of the stitched area with surface statistics. The natural volume of the stitched area, in which the surface after erosion would hold if it were covered just to the nominal surface of the highest peak, was obtained (fig. 7(d)). In other words, the volume necessary to submerge the stitched area of the surface with an erosion wear scar was calculated. This calculated volume is designated  $V_2$  in this investigation. Simply, the erosion volume loss (fig. 7(e)) can be expressed as the natural volume of the eroded surface minus the natural volume of the uneroded surface:

erosion volume loss = 
$$V_2 - V_1$$

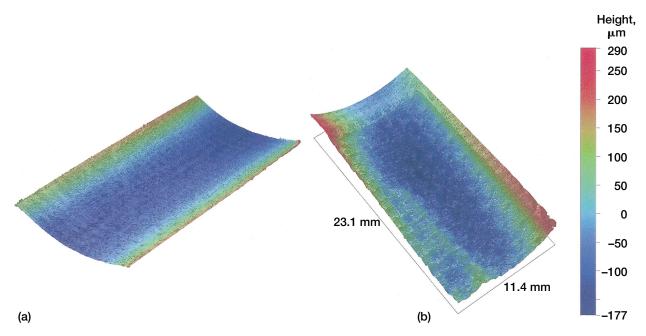
Figure 8.—Three-dimensional contour maps of coated specimen before and after erosion. (a) Uneroded, coated surface. Three-dimensional interactive display: three-dimensional contour map of the surface. (b) Eroded surface; impingement angle, 20°.

Thus, in the stitching method, the erosion wear volume loss was derived from the volume analyses of the three-dimensional contour maps obtained before and after erosion. Examples of the three-dimensional contour maps of a coated vane coupon specimen before and after erosion are given in figures 8(a) and (b).

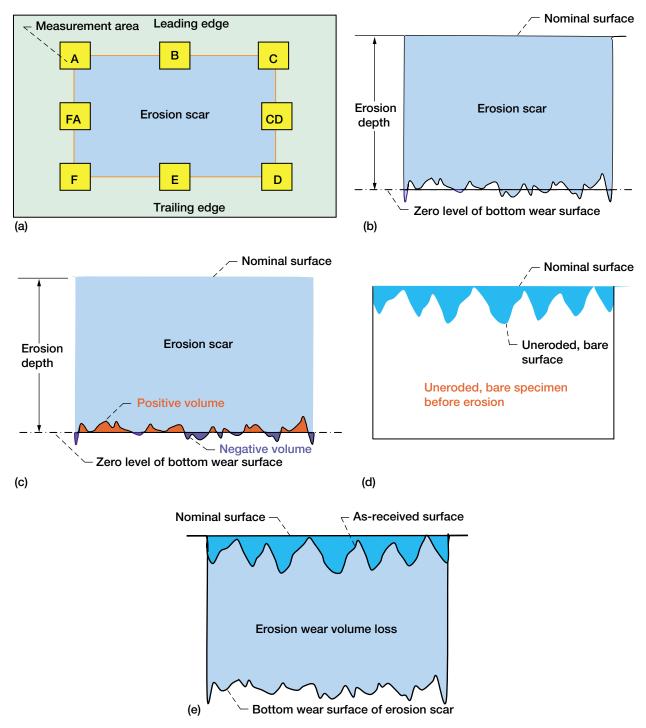
Figure 9.—Depth-measuring method. (a) Designation of sampling area. (b) Erosion depth. (c) Net missing volume of eroded area. (d) Natural volume of uneroded, bare surface. (e) Erosion wear volume loss.

To obtain the average erosion depth of an eroded scar, the erosion depth was measured at eight locations, which are designated in figure 9(a) on an eroded specimen. At each location, noncontact, optical interferometry profiled the surface topography, which included the eroded and uneroded areas.

The uneroded area was used as a reference for the erosion depth measurement. Eight contour maps were obtained from each erosion scar. The maximum erosion depth was obtained by measuring a step height between a nominal surface and a zero level of the bottom wear surface of the erosion scar in a cross-sectional profile (a two-dimensional slice of a surface) of each contour map. Then, the mean value of the eight maximum erosion depths was determined and defined as the mean erosion depth (fig. 9(b)).

The natural volume of uneroded, bare surface was obtained before erosion (fig. 9(d)). The natural volume of uneroded, bare area was randomly measured at eight locations. Then, the total natural volume of the area, which is equal to the eroded wear scar area, was calculated.

Thus, the erosion wear volume loss, which is illustrated in figure 9(e), can be calculated as follows:

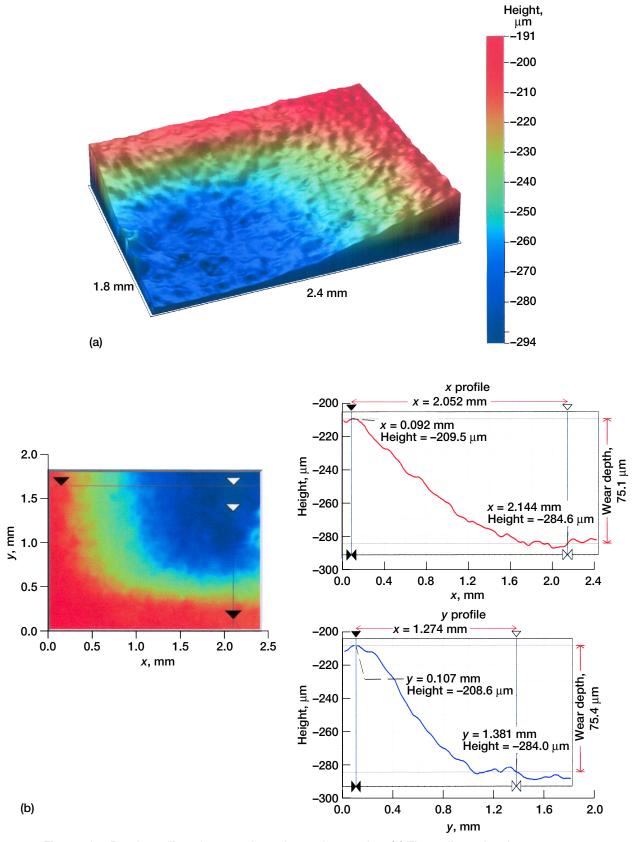
Figure 10.—Depth profiles of a coated specimen after erosion. (a) Three-dimensional contour map. (b) Two-dimensional contours showing erosion depths.

Examples of a three-dimensional view and two-dimensional, cross-sectional profiles of part of an erosion wear scar used for the erosion depth measurement are shown in figures 10(a) and (b). The noncontact, optical interferometer profiled the surface topography, which included the eroded and

uneroded, bare areas. The maximum erosion depth was obtained by measuring a step height between a nominal surface and a zero level of bottom wear surface of the erosion scar in a cross-sectional profile (a two-dimensional slice of a surface) of each contour map (e.g., fig. 10(b)).

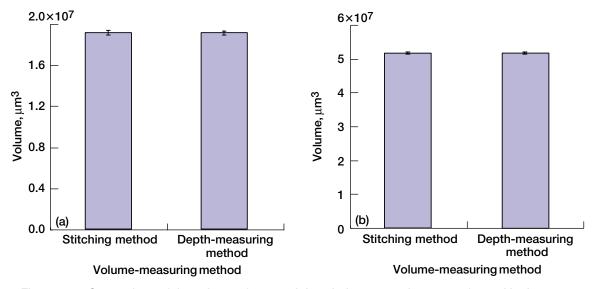
Figure 11.—Comparison of the volume of part and the whole rectangular groove formed in the stepheight measurement standard. (a) Part of the rectangular groove. (b) Whole rectangular groove.

The data presented in figures 11(a) and (b) indicate that there is no difference in the volumes measured by the stitching method and the depth-measuring method. The standard deviations of the measured values were smaller than 1 percent of the measured mean values. Either method can be used to determine the rectangular groove volume. Since the stitched area is relatively small and the surface of the measurement standard is flat and smooth, the measurement time using the stitching approach is much about the same as that with the depth-measuring method.

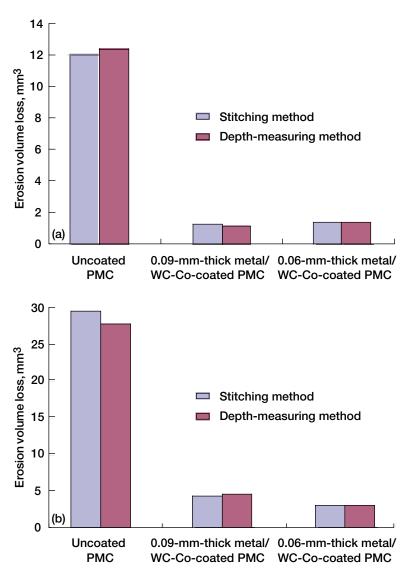
Figure 12.—Comparison of erosion wear volume losses of polymer matrix composites (PMCs) after impingement at 229 m/s and 383 K measured by the stitching method and depth-measuring method. (a) 90° impingement with 10 g of Arizona Road Dust (ARD) particles. (b) 20° impingement with 15 g of ARD particles.

*Erosion wear volume loss measurement.*—Figures 12(a) and (b) present, for impingement angles of 90° and 20°, respectively, the measured average values of erosion volume losses for the uncoated PMC, the 0.09-mm-thick WC-Co-coated PMC, and the 0.06-mm-thick WC-Co-coated PMC using the stitching and depth-measuring methods. The data presented in figures 12(a) and (b) indicate that there is no significant difference in erosion wear volume losses measured by the two methods. The difference in erosion wear volume loss is not significant because it is within 6 percent of the measured value and less than the standard deviation of each uncoated or coated PMC. The similarity of the values determined by the two methods means that the erosion wear loss over each erosion wear scar is very even.

Figures 12(a) and (b) also indicate that, in comparison with the erosion wear volume losses of uncoated, bare PMCs, the WC-Co coatings deposited on the PMCs markedly reduced the erosion wear volume loss: by a factor of 10 at an impingement angle of 90° and by a factor of 7 to 10 at an impingement angle of 20°.

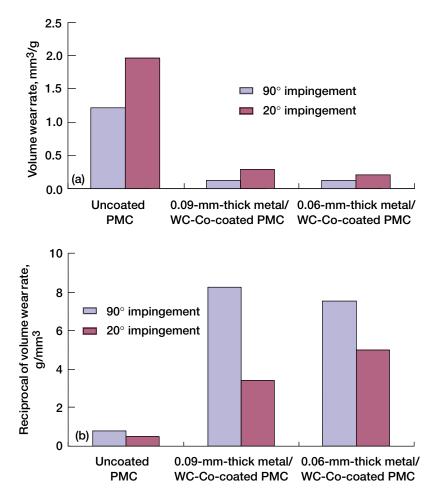
Figure 13.—Volume wear rate and erosion resistance for uncoated, bare polymer matrix composites (PMCs), 0.09-mm-thick metal/WC-Co-coated PMC, and 0.06-mm-thick metal/WC-Co-coated PMC subjected to impingement with ARD at 229 m/s and 383 K. (a) Volume wear rate. (b) Erosion resistance (reciprocal of volume wear rate).

Figures 13(a) and (b) present the volume wear rate (volume removed per unit mass of erodent particles) and the reciprocal of the volume wear rate (a measure of erosion resistance), respectively, for the uncoated, bare PMCs, 0.09-mm-thick WC-Co-coated PMCs, and 0.06-mm-thick WC-Co-coated PMCs. The erosion wear volume losses were obtained from the stitching method. The volume wear rates of both uncoated and coated PMCs depend strongly on the impingement angle, as illustrated in figure 13(a), which shows a greater volume wear rate at an impingement angle of 20° that decreases to two-thirds to one-half of the volume wear rate at normal incidence. Furthermore, it is interesting to note that the volume wear rate does not depend on the coating thickness.

In comparison to the erosion resistance of uncoated PMCs (fig. 13(b)), the WC-Co coatings deposited on the PMCs markedly enhanced erosion resistance. The tenfold increase in erosion resistance will contribute to longer vane lives, reduced erosion-related breakdowns, decreased maintenance costs, and increased vane reliability, which could lead to overall economic savings.

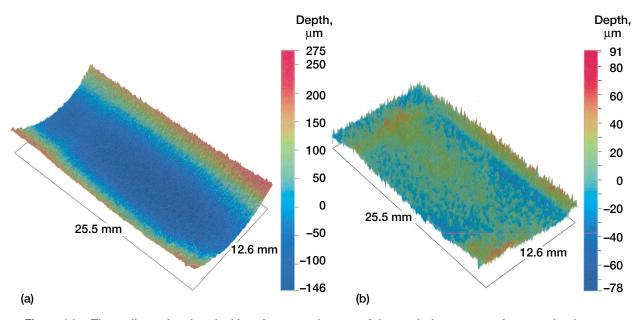
Figure 14.—Three-dimensional optical interferometry images of the eroded wear scar of a coated polymer matrix composite (PMC) sample obtained after an erosion test. The eroded surface appears as a large scar in the direction of the airstream containing abrasive particles. The erosion test was conducted at the University of Cincinnati with 15 g of ARD particles at an impingement angle of 20° and a velocity of 229 m/s at room temperature. (a) Three-dimensional display from measurement. (b) Three-dimensional display with cylindrical shape removed.

The vane specimens inherently have cylindrical characteristics, as presented in figure 14(a) as an example. This figure shows all the surface data, including the cylindrical characteristics. Figure 14(b) shows the plot in which the cylindrical characteristics have been removed from figure 14(a). Removing the cylindrical characteristics causes the vane specimen to appear flat, so that surface features, particularly surface roughness, can be observed instead of the dominant cylindrical shape.

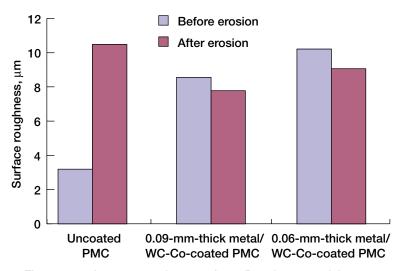
Figure 15.—Average roughness values,  $R_a$ , of uncoated, bare polymer matrix composite (PMC) specimens and coated specimens before and after erosion with 15 g of ARD particles at a 20° impingement angle, 229 m/s, and 93 °C.

Figure 15 presents average roughness values of the uncoated and coated specimens before and after erosion. Before erosion, the surface roughness values of the uncoated, bare vane specimens was one-third of those of the coated specimens. However, the surface of the uncoated, bare specimens was roughened because of erosion. The surface roughness of the uncoated vane specimens increased to threefold of the original surface roughness after erosion. On the other hand, the surface of the coated vane specimens was smoothed. The surface roughness of the coated vane specimens was decreased nearly 10 percent.
